# RDS 3110 – Interior Troubleshooting Guide

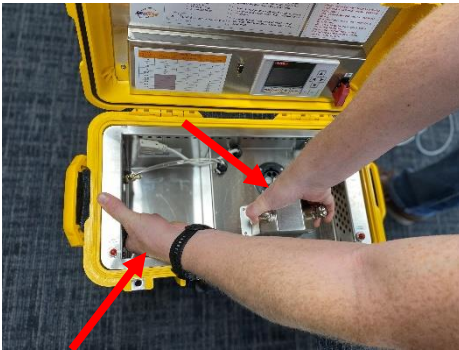
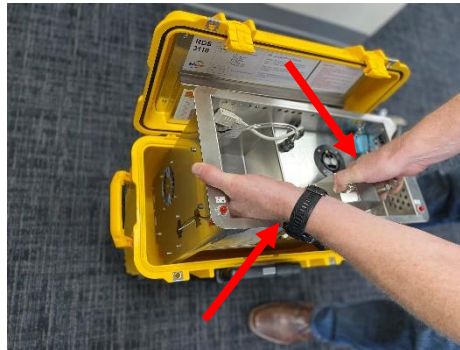
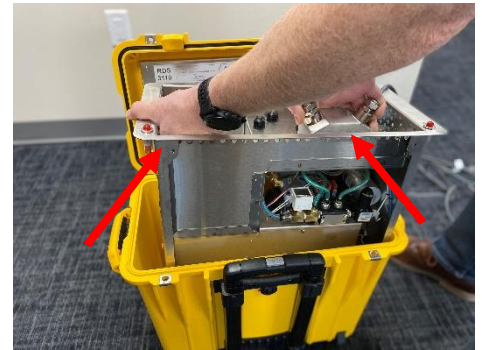
- 4) Grip the stainless-steel heads on the right side of the unit interior. Grab the grate of the left side of the unit interior and carefully lift the system out of the yellow case. Gently place the system on a flat, clean, stable surface.

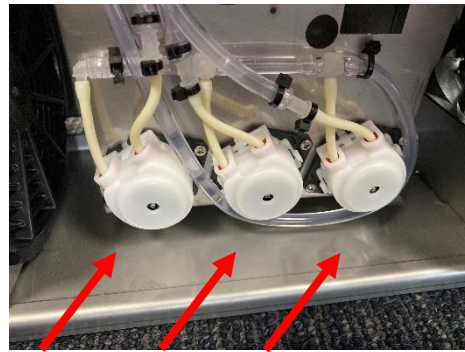
- 1)** Locate the pump impellers at the bottom right of the unit. These are the 3 white plastic disc shaped objects

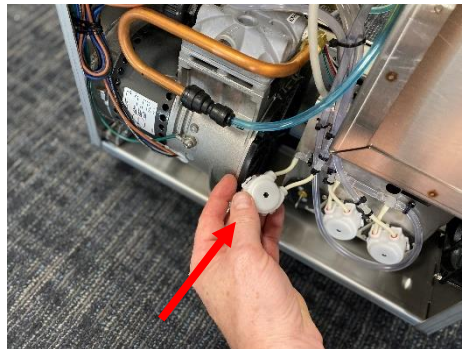
- 2)** Depress the 2 finger tabs located on the side of the impellers. Gently pull the impeller off the spindle which extends into the impeller.
